Service Bulletin

03/04/13
P8AM Series

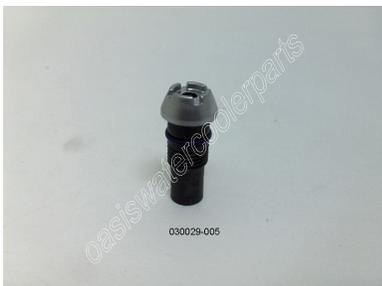
Part # 030029-005 Cap & Nozzle Assy.

Insert a 5/64 hex wrench approximately 1-1/8" into the bubbler nozzle opening until it bottoms out and is seated in an adjust screw. Turn the adjust screw clockwise to reduce the stream height or counterclockwise to increase the height. Note, less than one turn is required to go from a closed to a wide-open flow. Do not over tighten the adjuster in the closed position as stripping the hex impression in the adjust screw may result.

To determine if the nozzle or the cooler is the problem, unscrew the nozzle off of the top of the bubbler and activate the water via the pushbutton on the cooler. If the nozzle is defective the water should about hit the ceiling.

If nozzle has too much mineral buildup, cannot be adjusted or is stripped out replace the nozzle assy. part # 030029-005.

Part # 032799-005 is the complete Bubbler and includes the nozzle assy. If you order the bubbler order part # 026824-019 hex nut that secures it under the top.

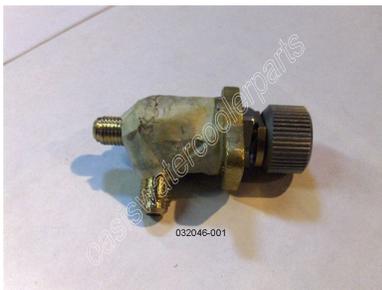
Part # 032046-001 Valve & Body Assy. This includes part # 013059-005 Valve Stem and part # 032045-002 valve body. If hard water deteriorates the valve body order part # 032045N002 Nickle Plated Valve Body and part # 013059-005 valve stem.

This procedure should be used to correct “continuous flow” complaints or during valve stem replacement. Insure that the valve body cavity and valve stem seat seal are free of scale buildup and damage. The water valve is located behind the nose panel.

1. With stem assembly installed in valve body and all operating linkage in place, turn on water supply.
2. Remove cotter wire from valve stem.
3. If water is flowing from the bubbler nozzle, turn the castillated nut on the valve stem CCW until water flow stops.
4. Turn the castillated nut CW until water flow just starts. Turn castillated nut 120 degrees (two notches) CCW, flow should stop. Continue to rotate the castillated nut CCW until notches line up with hole in valve stem. Reinstall cotter wire and replace panels.

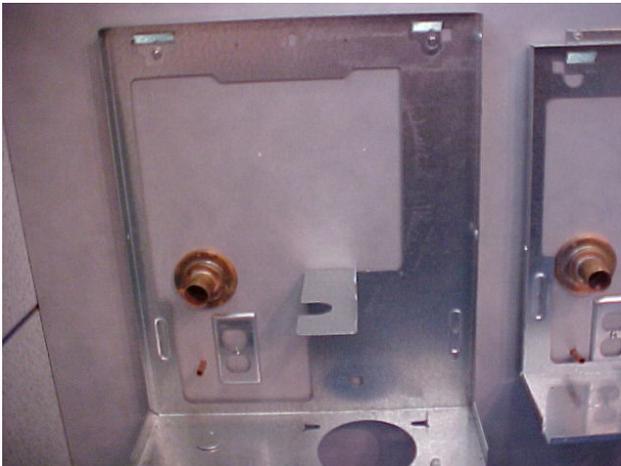
P8AM Rough-In

For model P8AM model P8AC is the replacement. Use part # 035421-001 bracket to use the same rough-in, however using this bracket will lower it below the ADA guidelines. If you need this ADA they will have to modify the unit or change the rough-in.

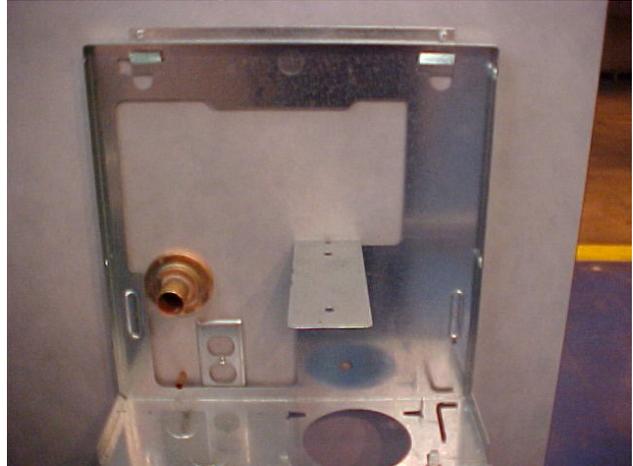
P8AC mounting with 035421-001 bracket

Part # 035421-001 bracket mounts in same holes and lowers cooler 1 ½". Maintains 27" knee clearance.

For model P8AMSL model P8ACSL is the replacement. Use two of the 035421-001 brackets to use the same rough-in, however using these brackets will lower it below the ADA guidelines. If you need this ADA you will have to modify the unit or change the rough-in.
